Proper Functioning Condition
And
Amendment 6 Assessments and Ratings
For
Templeton Allotment
Summer 2010

Prepared by: Lisa Sims, Inyo National Forest Aquatic Biologist

March 2011

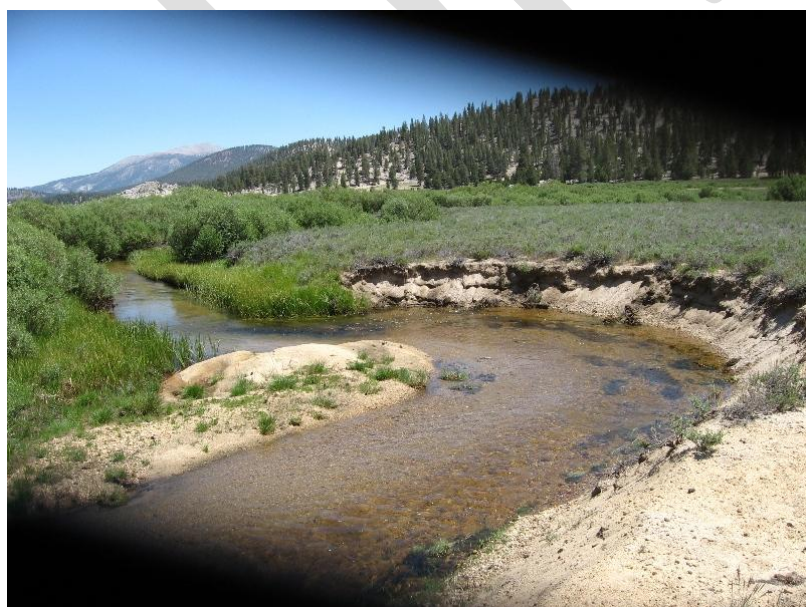
recent sand/sediment deposition is when these areas are particularly vulnerable to excessive disturbance that can disrupt the vegetation establishment process, of which the timing should be taken into consideration during management decisions.

Photo left: An example of the high alluvial terrace dominated by sagebrush vegetation, which brought the PFC rating to FAR due to the lack of riparian vegetation on the terrace. However, this is part of the natural dynamic of this system as the river moves laterally into these alluvial deposits that originate from the steep, sandy uplands.

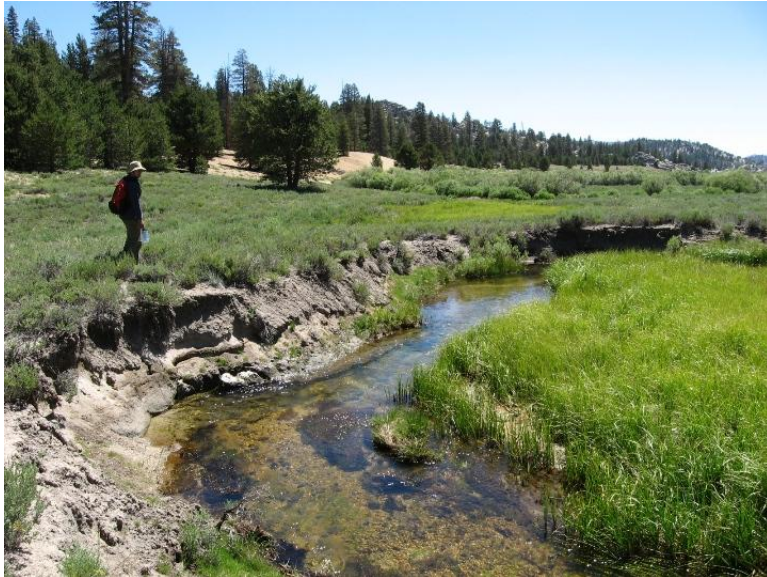
Proper Functioning Condition: PFC was rated at Functioning at Risk with an Upward Trend. An analysis of the width to depth ratio for this section of stream completed after the field visit clearly identified the channel width to be within the expected range for the size of the upper watershed. This

reach of the stream appeared to be stabilizing with abundant and vigorous vegetation along the streambanks with limited lateral movement, which was increasing the sinuosity throughout the reach. Lateral movement was evident in some of the high terraces, as shown in the adjacent photo. One beaver dam was observed that had recently breached, bringing the rating down from PFC to FAR with an upward trend. However, new oxbow channels had formed and banks are well-vegetated, and the presence of the dam had increased the area of wetland vegetation. Also, there was an abundant source of sediment behind the

beaver dam, which was being dispersed, and trapped, within the channel below.
